Building Number:	614
Area:	West Barracks
Date of Construction:	1904
Period of Significance:	1900-1919 (per HSR Part One)
Historic Use:	Hospital
Current/Recent Use:	Offices
Occupancy:	I-1.2 then B
Hazard Level:	Not Available
Number of Floors:	Three stories
Basement Floor:	7,026 sq. ft. (per January 2000 SERA report)
First Floor:	8,082 sq. ft. (per January 2000 SERA report)
Second Floor:	8,082 sq. ft. (per January 2000 SERA report)
Third Floor:	6,064 sq. ft. (per January 2000 SERA report)
Exterior Materials:	Painted red brick, wood tongue and groove at porches, wood shingle siding at dormers.

Task One: Conditions Assessment

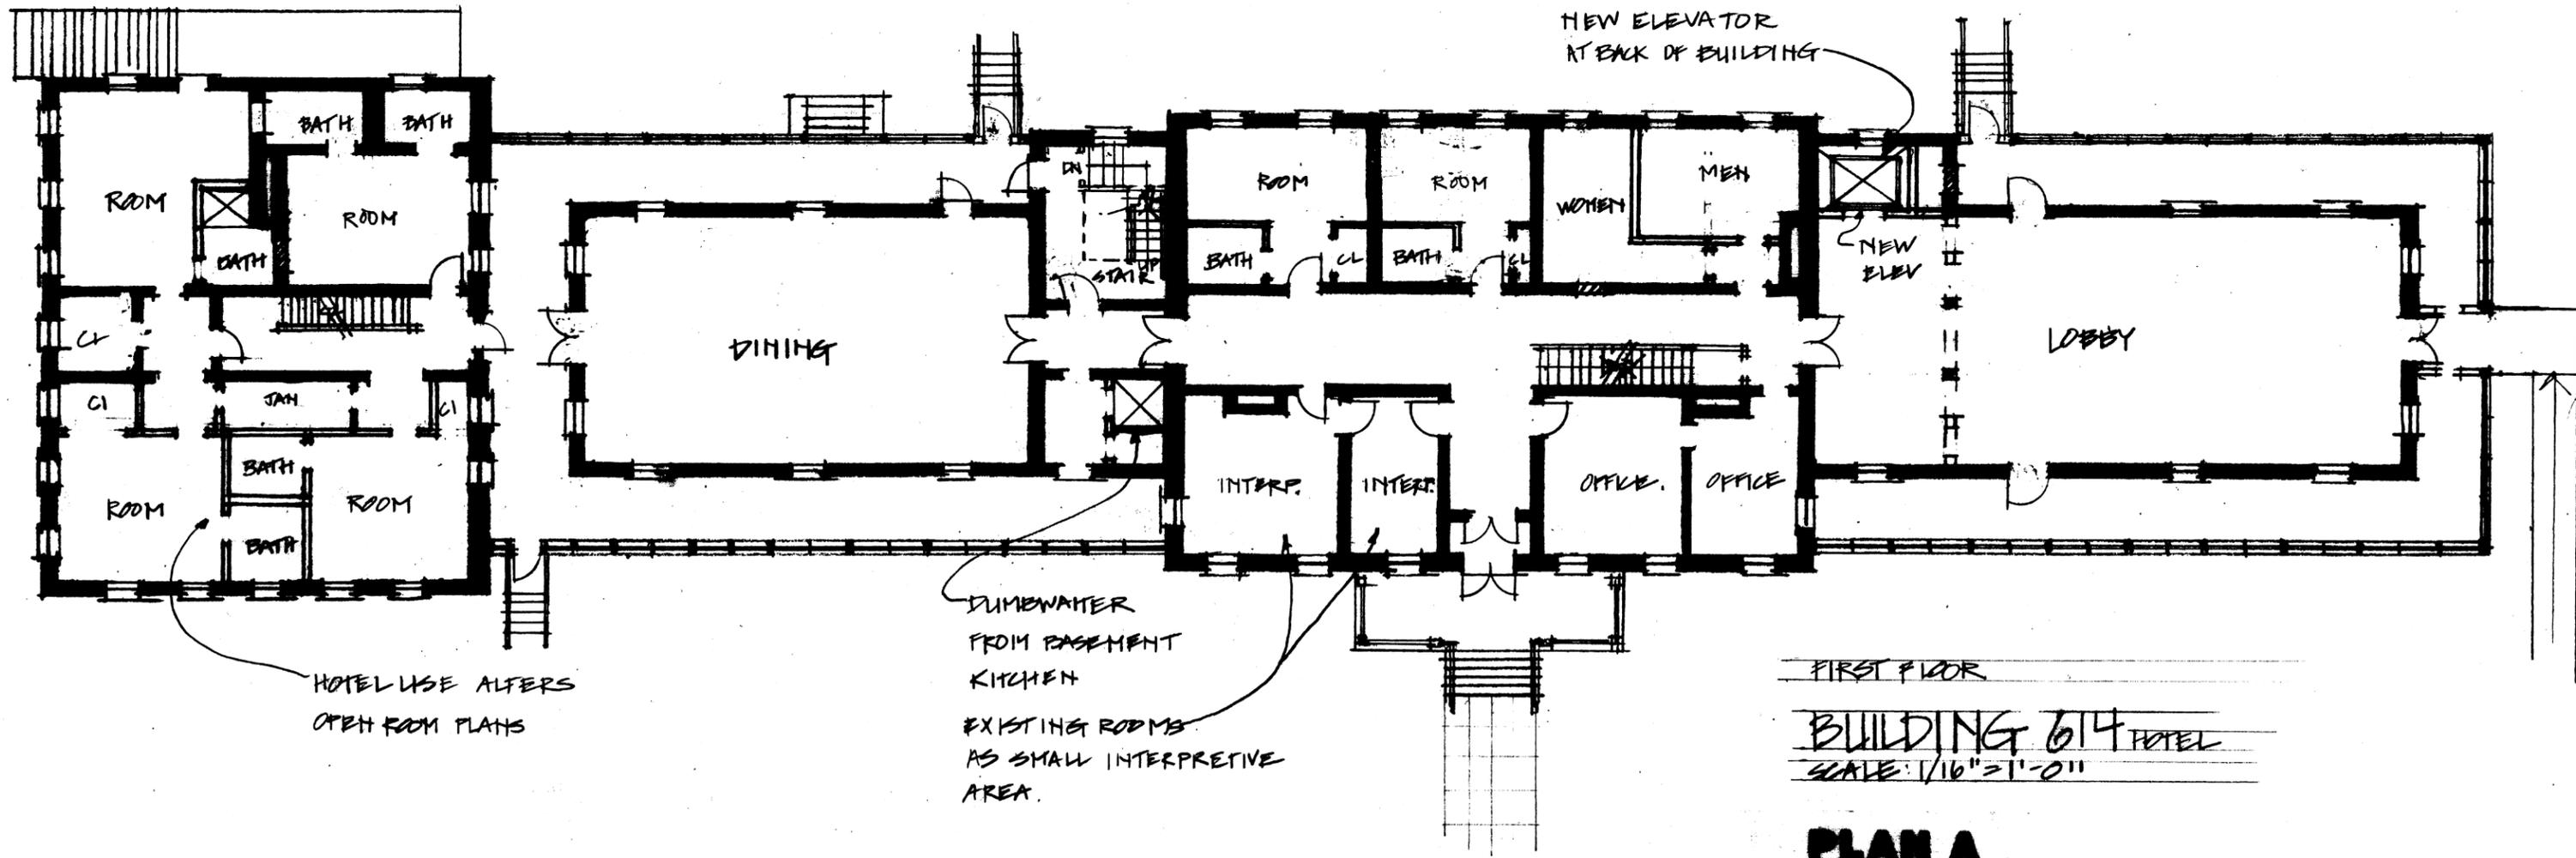
FIRST FLOOR
BUILDING 614 HOTEL
SCALE 1/16" = 1'-0"

HOTEL USE ALTERS
OPEN ROOM PLANS

DUMBWATER
FROM BASEMENT
KITCHEN
EXISTING ROOMS
AS SMALL INTERPRETIVE
AREA.

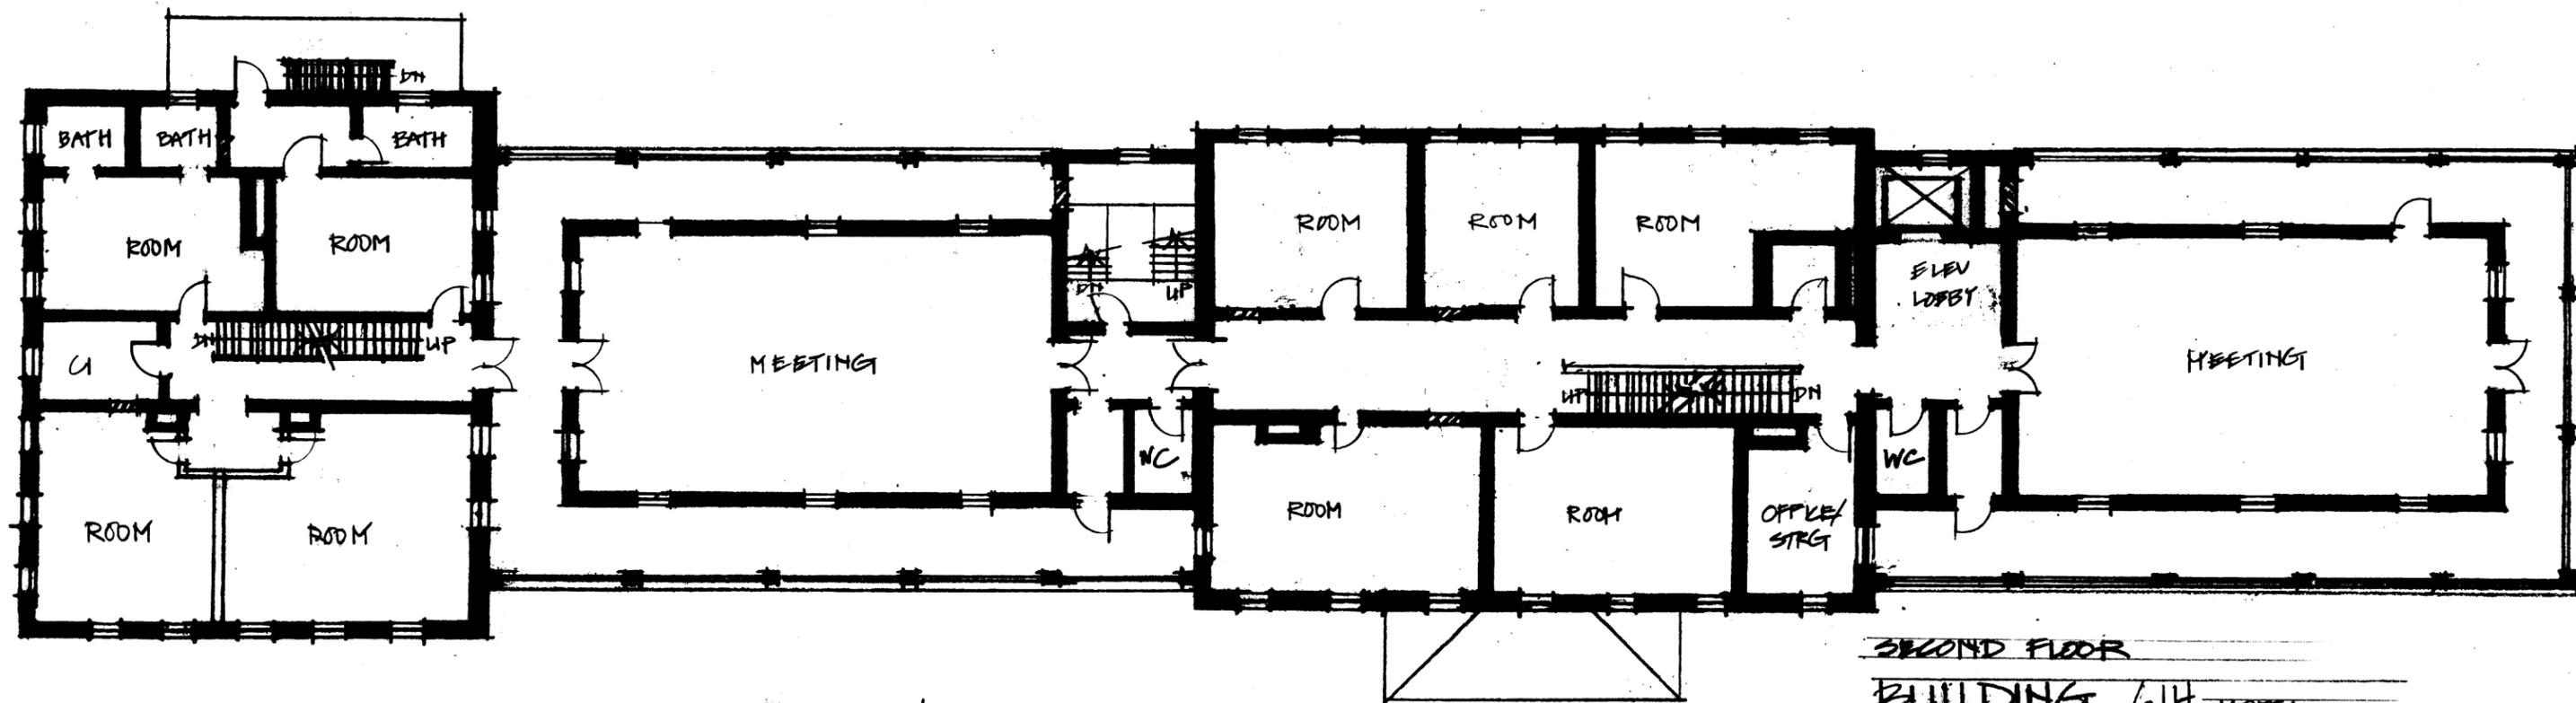
SECOND FLOOR
 BUILDING 614 HOTEL
 SCALE 1/16" = 1'-0"

NOTE: 3rd FLOOR CAN
 ACCOMODATE 8 ROOMS.
 BASEMENT CAN HOUSE
 SUPPORT STALCS.

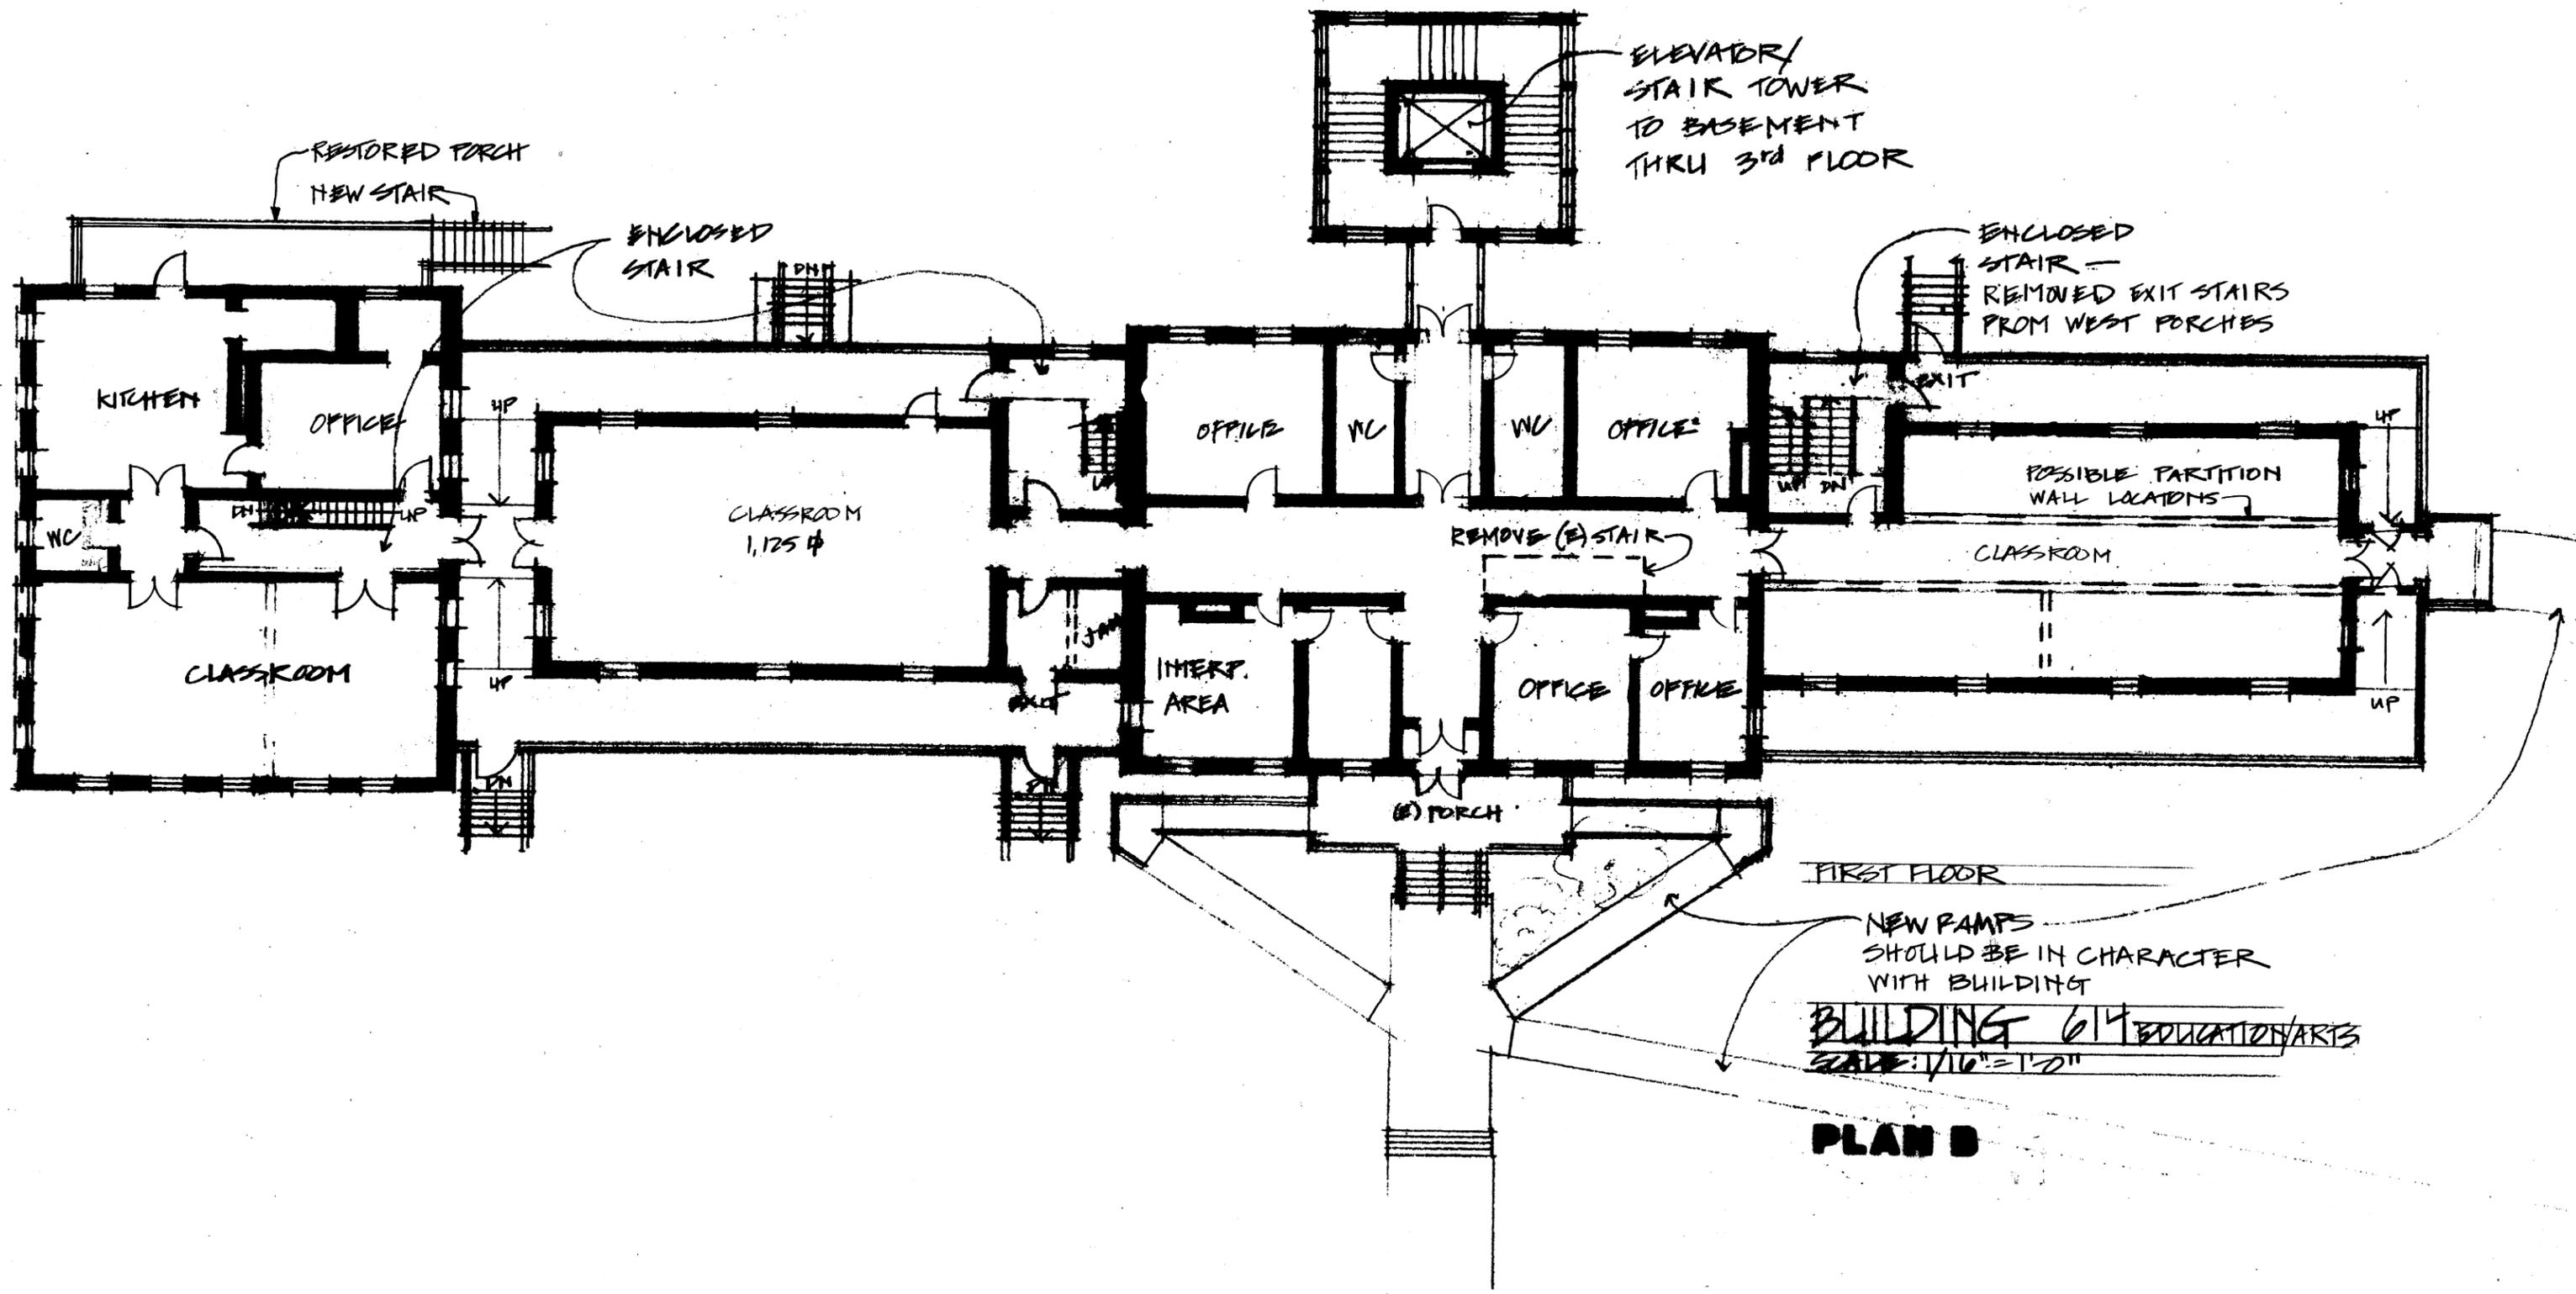
BUILDING 64 EDUCATION/ARTS
SCALE: 1/16" = 1'-0"

ELEVATOR/
STAIR TOWER
TO BASEMENT
THRU 3rd FLOOR

RESTORED PORCH
NEW STAIR
